FIELD SHEET--HISTORIC RESOURCES SURVEY

SURVEY NUMBER: CARR- 1141

DATE BUILT: late 19th c.COUNTY: CARROLLTOWN: MelroseLOCATION: 4219 HANOVER PIKE (MD 30)

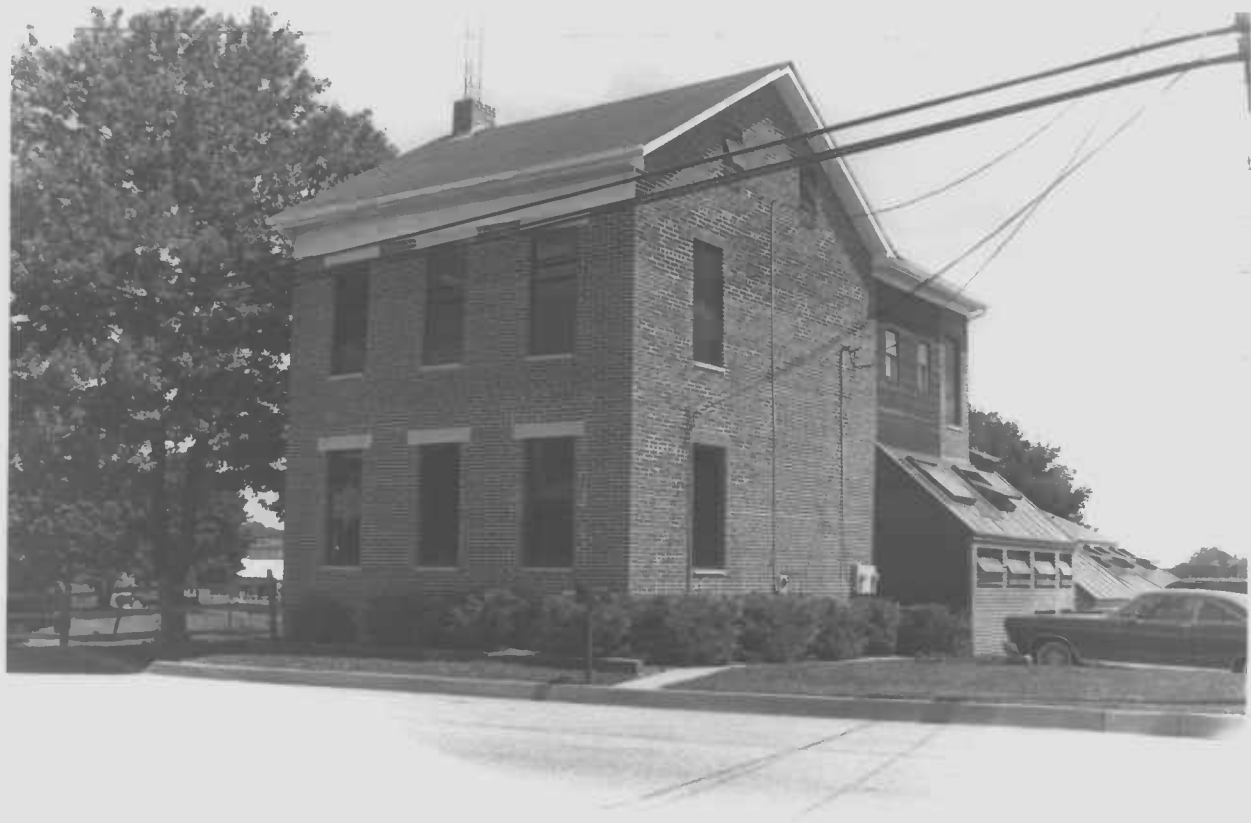
1. CARR-1141
2. Carroll County, Maryland
3. Joe Getty
4. July 1985
5. Maryland Historical Trust, Annapolis, Md.
6. West elevation (camera facing east)
7. 1/1
